**DOT/FAA/CT-92/04**

# **Commuter/Air Taxi Ditchings and Water-Related Impacts that Occurred from 1979 to 1989**

July 1994

Final Report

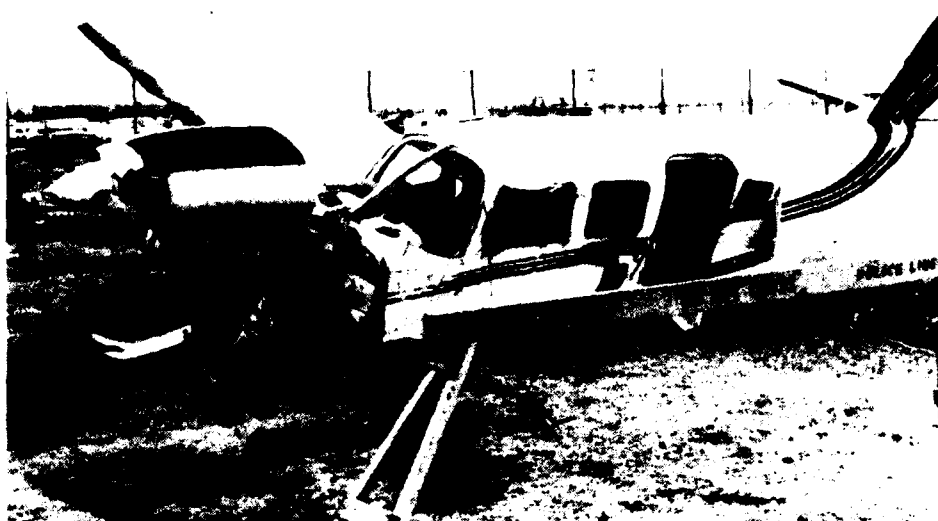
FIGURE 4.11. CASE STUDY 6, FULL VIEW OF LEFT FUSELAGE DAMAGE

- a. Left wing completely separated from fuselage and inverted (figure 4.11).
- b. Forward upper left fuselage side indentation resembling left wing tip (figure 4.11).
- c. Fuselage door under the wing (figure 4.11).
- d. Left, right, and nose gear in down position (figure 4.12).
- e. Nose wheel and lower part of nose strut missing (figure 4.11).
- f. Right wing tip missing (figure 4.12).
- g. Rudder slightly wrinkled.
- h. Nose crush damage (figure 4.11).
